#### PRELIMINARY ASSESSMENT/ VISUAL SITE INSPECTION

CIBA-GEIGY CORPORATION EAST LANSING, MICHIGAN MID 067 352 989

#### FINAL REPORT

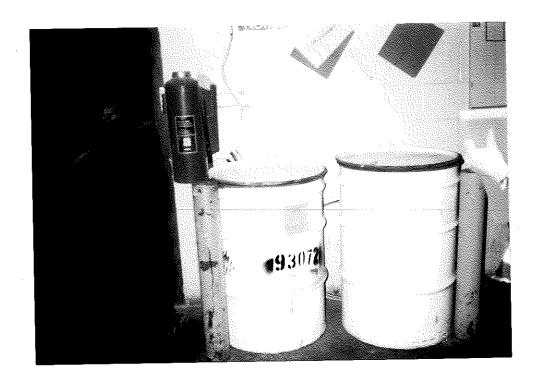
Photograph No. 1
Orientation: West
Location: SWMU 2
Date: 5/26/93

At the time of the VSI, PRC observed two 55-gallon drums of waste with waste code D001 and two 55-gallon drums of waste with waste code F005 (see Photographs No. 1 and 2).

Description: Hazardous Waste Management Unit II; waste is located indoors on a concrete floor in

this unit

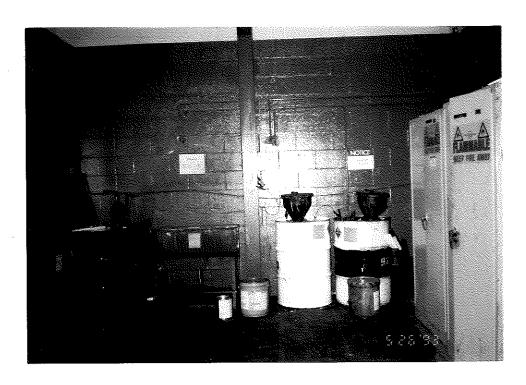
Photograph No. 2
Orientation: North
Location: SWMU 2
Date: 5/26/93

Description: Hazardous Waste Storage Area II; parts washers are located on the left

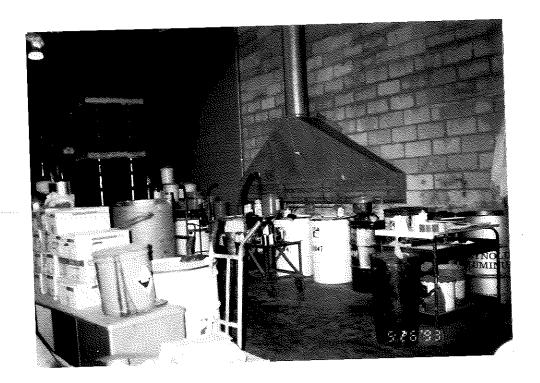
Photograph No. 3 Location: SWMU 1
Orientation: Northeast Date: 5/26/93

The unit contained the following hazardous wastes at the time of the VSI: one 55-gallon drum of D009, one 55-gallon drum of F002, one 55-gallon drum of D001 and F005. The unit contained the following nonhazardous wastes two 55-gallon drums of resin, one 55-gallon drum of isocyanate, and one 55-gallon drum of acrylic. PRC did not observe any signs of spills or leaks at the unit (see Photograph No. 3).

Description: Hazardous Waste Management Unit I; waste is located indoors on a concrete floor in

this unit; drums containing waste are located in the foreground

Pending MDNR closure approval, PRC recommends no further action for this unit.

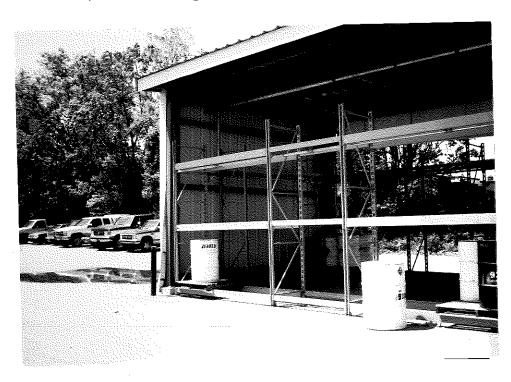
Photograph No. 4 Location: SWMU 3

At the time of the VSI, PRC observed five drums in the unit with waste code F005 and four drums containing waste with waste code D009. All drums were located on wooden pallets (see Photographs No. 4 and 5). Stormwater sewers that discharge to the Red Cedar River are located about 40 feet south of the unbermed unit. On-site soils are located about 30 feet from the unit.

Description: Hazardous Waste Storage Area III; waste is stored within the shelter; the south side of the shelter is used for waste accumulation; the north side is used for raw material

storage

Pending closure of this unit, PRC recommends no further action.

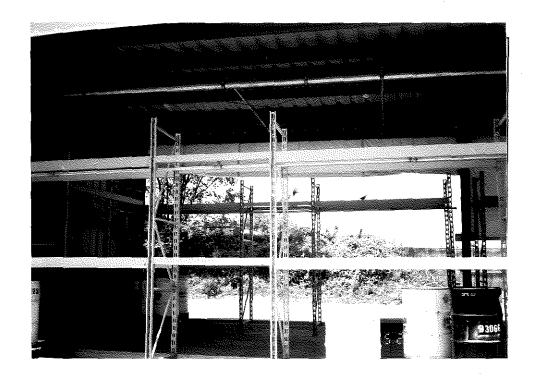
Photograph No. 5 Orientation: Southwest

Hazardous Waste Storage Area III; drums containing waste are on pallets
